# **ROOF ASSESSMENT REPORT**

**DUVAL ELEMENTARY SCHOOL**

**NOVEMBER 08, 2010**

**WHITMAN HANSON REGIONAL SCHOOL DISTRICT**

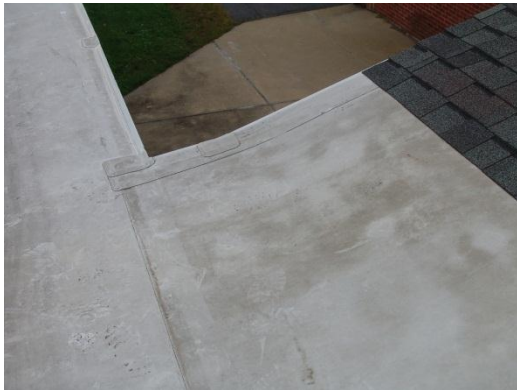
### **Observation No. 1**

Loose PVC membrane at transition slope, main PVC flat roof, coordinate C9.

Review periodically for evidence of leaks below.

Remove/replace or re-adhere PVC roofing.

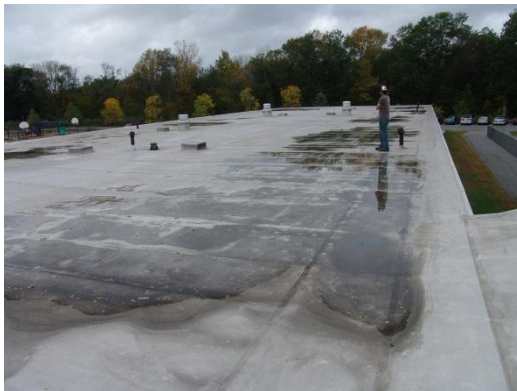
### **Observation No. 2**

Ponding water, main PVC flat roof, coordinates C10-I10.

Remove debris and organic growth, clean impacted roof areas.

Inspect problematic areas yearly for evidence of leaks. Coordinate installation of crickets/tapered insulation (to positively drain water to internal roof drains) at time of future roof replacement.

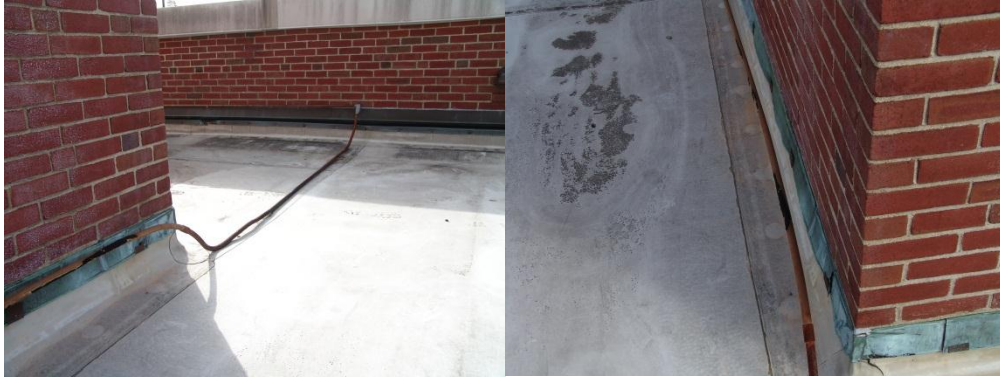
### **Observation No. 3**

No roof protection or fasteners at exposed conduit, main PVC flat roof, coordinate C16.

Remove abandoned conduit or install PVC protection pads and fasten to masonry wall construction (not flashing).

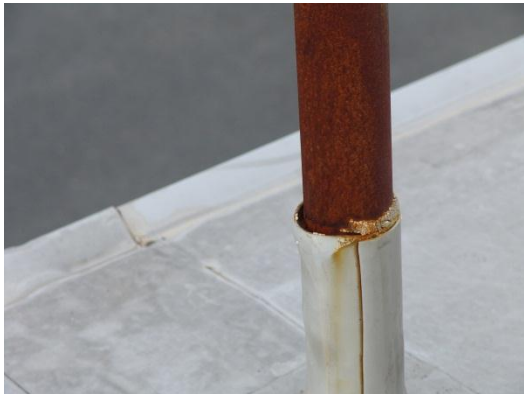
**Observation No. 5**

Missing ring clamp at penetration, main PVC flat roof, coordinate E14.

Remove sealant/debris, clean and apply compatible sealant- set into/install ring clamp.

Inspect details with sealant yearly and replace as part of ongoing maintenance plan.

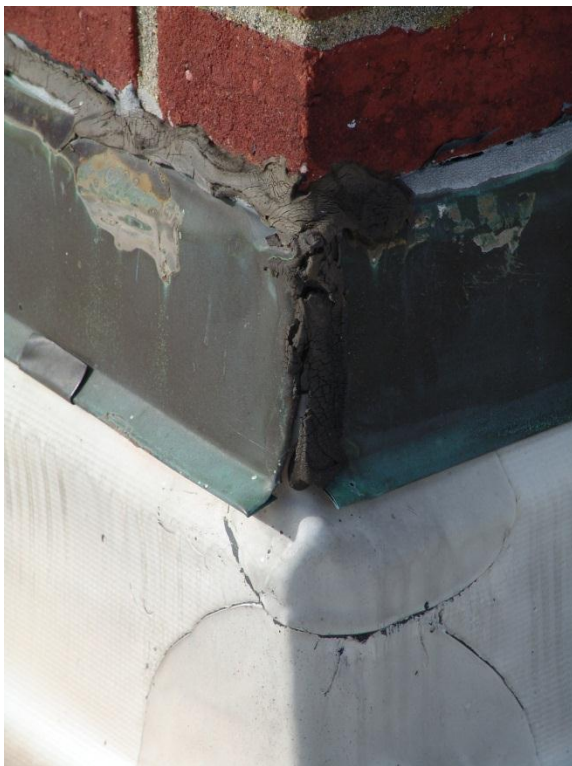
**Observation No. 6**

Open flashing corner/ seam, excessive sealant-possible past leaks, intermediate upper PVC flat roof, coordinate C20. Indicative of detail at original counter flashing.

Inspect yearly for evidence of leaks below. Apply sealant and copper flashing patches/covers.

Consider staged replacement of copper through-wall/counter flashing at original building details, during future roof replacement projects.

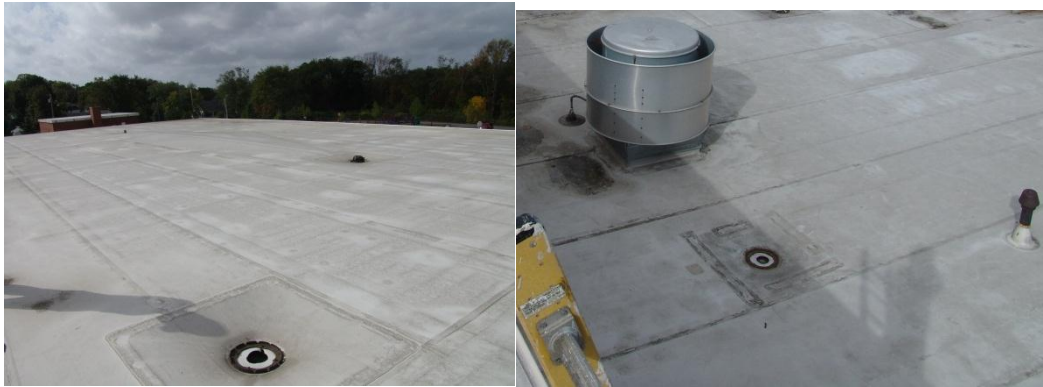
### **Observation No. 7**

Missing roof drain baskets (6), upper PVC flat roof, coordinate A12, main PVC flat roof, coordinate B11, C11, D14, D15, D21.

Clean debris, install new roof drain baskets. Consider metal baskets, properly fastened.

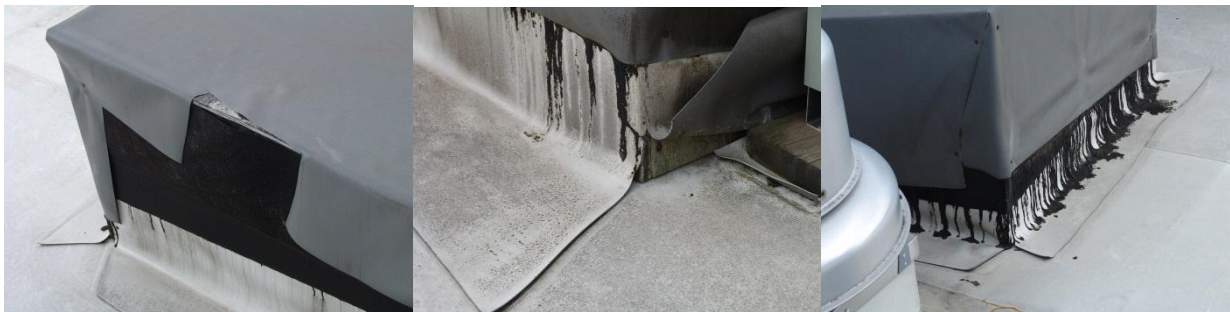
### **Observation No. 8**

Missing/sliced membrane, exposed plywood enclosure, not flashed to main roof membrane, upper PVC flat roof, coordinate D3.

Install compatible EPDM patch, inspect yearly.

Remove and rebuild/fasten enclosure onto PT curbing, properly flash to main roof membrane at the time of future roof replacement.

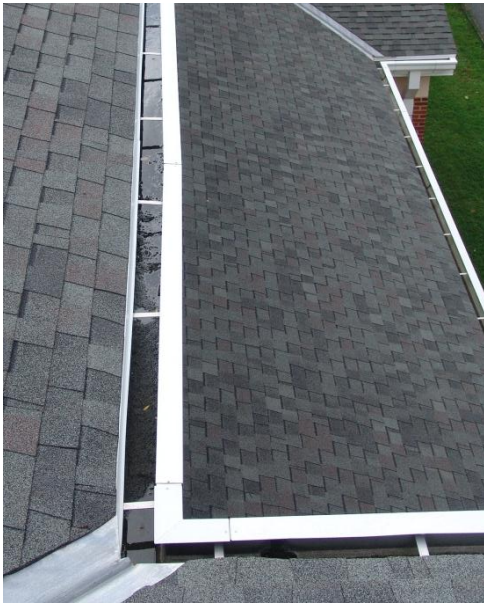
**Observation No. 9**

Standing water/debris in gutter, upper asphalt shingle roof, coordinates E4-F4, E5-E8

Clean gutters, remove debris.

Inspect, clean gutters yearly as part of ongoing maintenance plan.

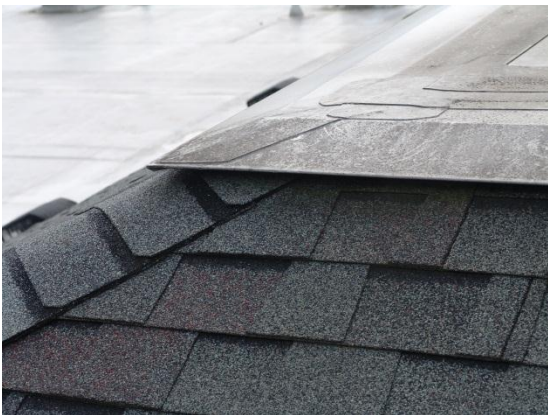
**Observation No. 10**

Similar condition to that identified as problematic at lower elevation. Transition vent detail sloped-to-flat roof, high sloped asphalt shingle roof perimeter, photo at coordinate E2.

Inspect yearly for evidence of leaks below. Varied adjacent conditions at transition vents below are likely reason for leaks at below condition, but not at upper condition.

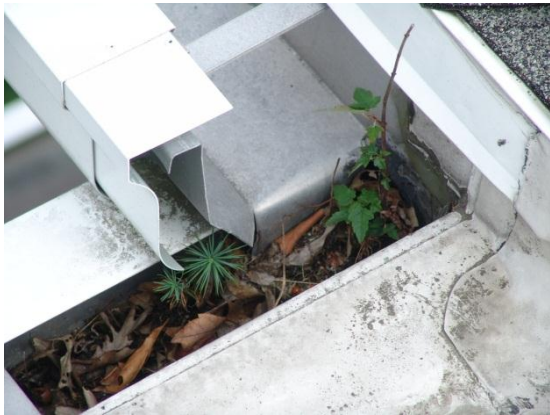
**Observation No. 11**

Debris/organic matter in gutter, upper asphalt shingle roof, coordinate G4.

Clean gutters, remove debris.

Inspect, clean gutters yearly as part of ongoing maintenance plan.
