WHITMAN MIDDLE SCHOOL

Building Assessment

Executive Summary

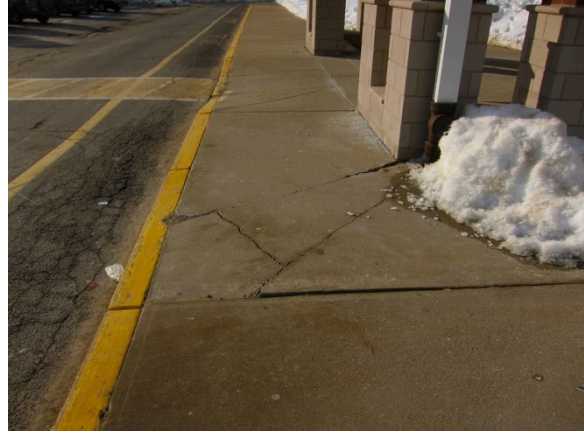
The walkways around the main entrance are in need of repair. There are a number of places where the concrete is experiencing heaves and depressions during the cold weather. The catch basins are most noticeable. There are severe depressions around the catch basins creating tripping hazards. Cracks in the concrete are noticeable around the campus grounds.

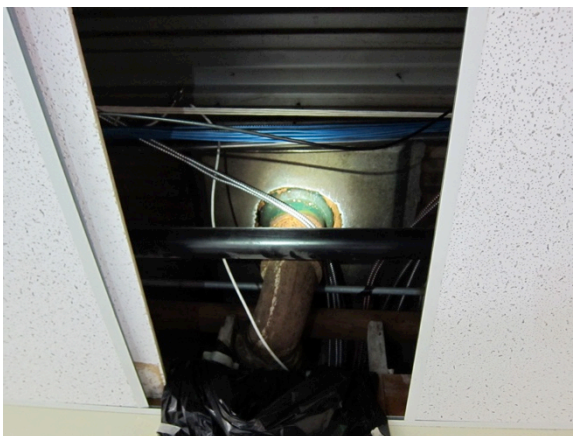
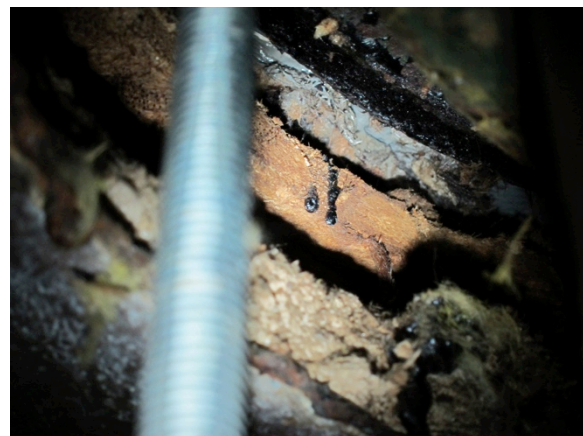
Recently, there have been numerous problems developing with the building's roof. There was a core sample taken from the roof to help identify the multiple layers and test for potential problem sources. Lab testing confirmed decomposition occurring within the layers of roofing material. The most likely source is the fiberboard that

was part of the original roof. Observations made at the penetration points for roof drains and vent stacks indicate significant moisture build up at this layer. One such penetration point showed signs of mold growth. The problems seem to be most severe in the gymnasium.

Inside the gymnasium, particularly during summer months, there is a bad odor. Due to the lack of a dropped ceiling in the gym, temperature differences hitting the interior metal deck and the top of the roof are more significant. This differential is more conducive to moisture buildup and is most likely accelerating decomposition of the fibrous material in the roof.

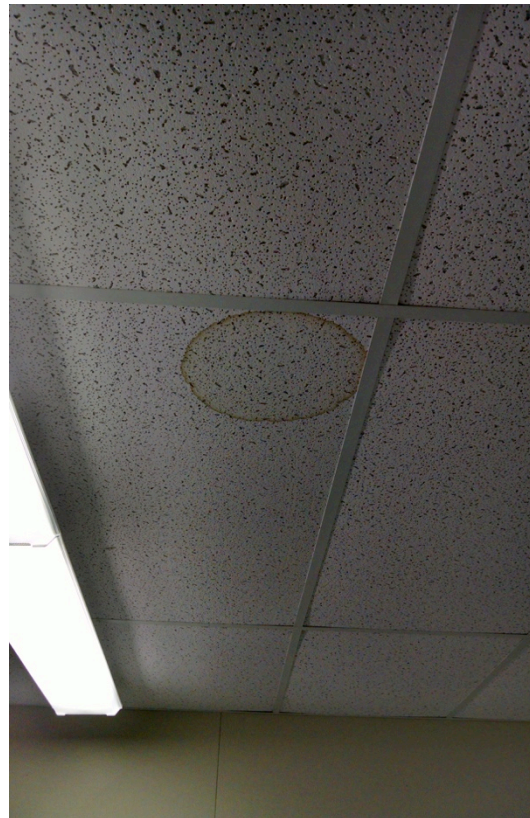
The ceilings throughout the building are mainly 2'x4' acoustical ceiling tile (ACT) in a dropped grid system. The grid system hangs 4' below the deck. There is sufficient space above the ACT for utility usage. Some of the tiles showed clear signs of moisture leaking or condensing above and saturating the material. The items most commonly associated with leaks were the roof drains. Roofing seals around the drains were clearly leaking and creating damage to the interior ceiling materials. Inspection around the roof drain connections revealed more evidence of decomposition of the wood deck at the base of the roofing materials. A moisture meter was used on the exposed wood and it was found to contain more than 30% moisture.

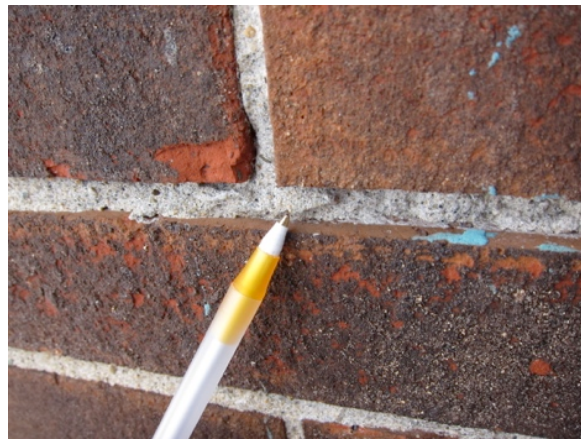
The exterior walls are unpainted brick on a concrete foundation. Most of the building is one floor and there is one main length of construction that is two floors. The 2000 renovation added a portion of the building at the main entry. The condition of masonry work around the addition is good. There were no signs of weathering, cracks, or spalling along the addition. Conditions of the 1972 construction were fair. There were signs of weathering in the masonry.

The exterior surfaces had cracks, spalling, and stains. The mortar joints around the original construction showed signs of moisture penetration and chunks of the mortar were missing. The brick surfaces were spalling in some places with frequent stains and small cracks. The expansion joint fillings were dried out and separating from the masonry. These joints are no longer weather proof. The concrete foundation surfaces were also spalling with some small cracks, and there were larger spots of missing chunks in some places. The penetration points for ventilation had larger gaps forming around the edges.

Repointing of the older masonry may be needed. The expansion joints should be replaced. There should be repairs made to the concrete foundation, particularly around high use places such as the loading docks behind the kitchen area. Finally, some attention should be given to the vegetation at the southeast corner of the building. Some branches are touching the building and providing easy access to the roof for rodents or vandals.

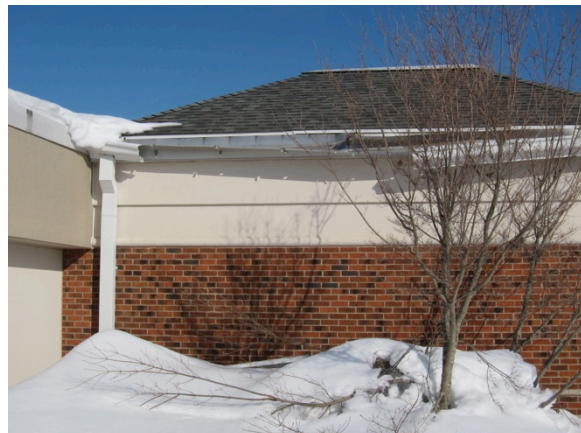
There was some damage found to the gutters and roof flashing around the newer construction near the nurse's office. A section of the gutter has broken and was hanging down from the side of the building. Along that same edge, there was a section of the flashing

that was deformed and bent upward. This damage appeared to be the result of some impact. The source was not obvious.

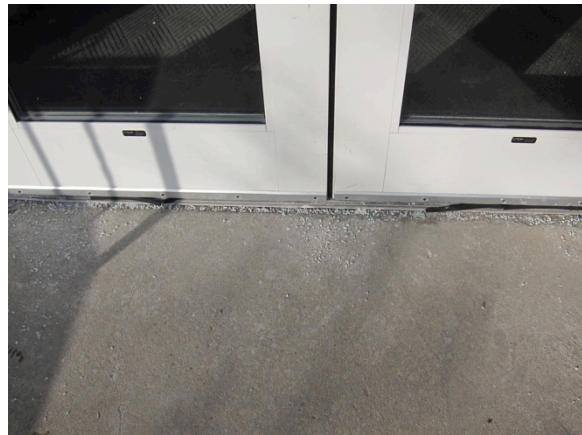
The windows and doors are in overall good condition. All hardware is in place and the windows appear to operate properly. The panic bars on exit doors operate without any apparent problems. The window shades also appear to function properly in most cases. All of these systems were installed during the renovation in 2000. The weather stripping and seals around many of the doors and windows are failing.

Large portions of weather stripping are missing or obviously broken. The most noticeable places are around the entry doors. This problem can also be observed around the windows throughout the building. The obvious ramifications of this problem are loss of heating efficiency. The selected glass for all windows has a U-Value of .58; the thermal transmittance for windows in this region should be lower than the selected product. The local climate is better suited for a U-Value between .17 and .39. Replacement of the windows and doors would provide a reduction in heating costs. The window shades offer some protection from solar heat gain during the warmer months.

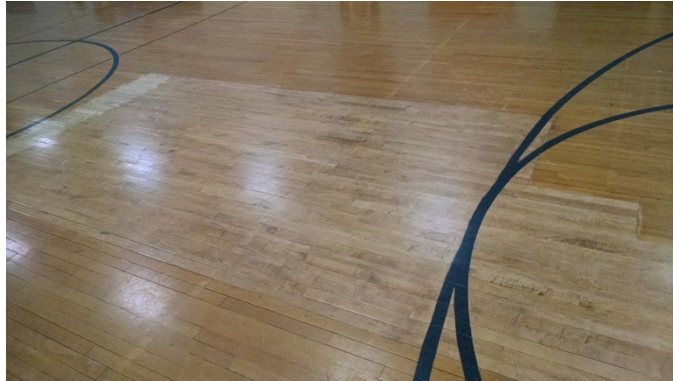
The school has already targeted the gymnasium as an area for improvement. Due to the construction methods used in repairing the roof, the gym has a very high moisture level, which is detrimental to the maple floor in the gym.

We used a meter to measure the amount of moisture in the floorboards of the gym. The measurement was 11%, which indicates between 60 and 75 percent humidity. The elevated humidity is causing the boards to swell and create the noticeable heaves along the gym floor. The humidity is also conducive to mold growth in the gymnasium. The indoor humidity should be maintained at 30 to 60 percent in order to reduce the possibility of mold growth.

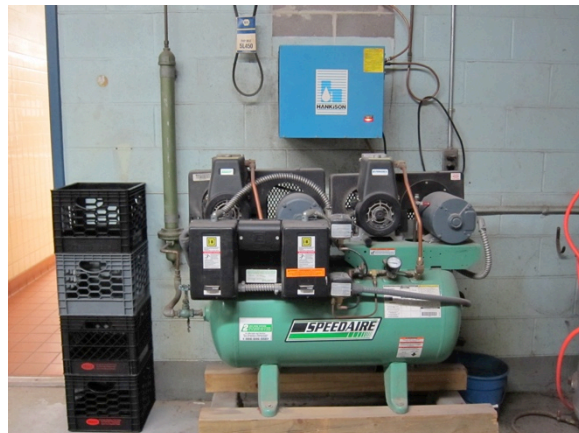
The building is currently using a pneumatic system to communicate commands from the controllers (thermostats) to the cabinet heaters located throughout the facility. There is a single source of compressed air located adjacent to the boiler room and near the backup power generator. The two compressor motors work

alternately and can be observed turning on every 2-3 minutes; the persistent running is indicative of leakage in the pneumatic lines.

During the next planned renovation of the facility, both the controllers and the heating cabinets should be scheduled for replacement. The new equipment would reduce maintenance costs and provide more dependable heating throughout the facility. When this conversion takes place, consideration should be given to placement of the new circuits. The new circuits should be designed to fail in the open position allowing the heat to remain on in the event of power loss. Additionally, the controllers will require a transformer to reduce the 120-volt house system to the lower voltage digital systems.

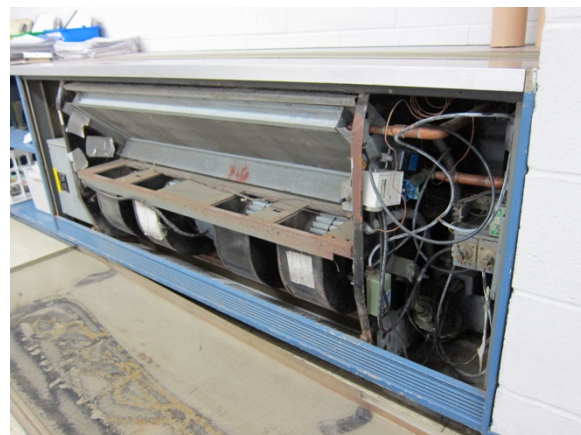
The Cabinet Unit Heaters are Nesbitt Aire syncretizers. The units were part of the original construction. These units have outlived their expected useful life. There have been routine trouble calls associated with these units across the facility. Reactive maintenance costs associated with these units are accounting for increasing portions of the facility's budget. In addition to the reactive maintenance costs, the pneumatic controls are subject to

persistent air leaks, which have lead to constant running of the electric motors. The wasted energy is surely costing the school district more money than the replacement costs over time. The units could easily be replaced by updated equipment that is readily available from the same manufacturing company.

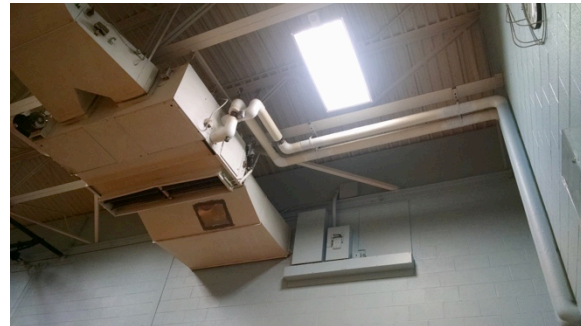
The large air handlers, located in the gym and the smaller exercise room, appear to be in good condition. We had limited access to the roof during our assessment due to the snow and further inspection of the air intakes on the roof should be completed.

Both air handlers do suffer from small dents in their piping and ductwork. Although much of this is negligible, larger dents may cause issues with airflow in the ducts and water flow in the pipes. Any dent significant enough to impact the efficiency of the air handler should be repaired. The air handler in the gym may also be working harder to maintain occupant comfort, given the high levels of humidity in the gymnasium. Any steps taken to reduce the moisture levels in the gym would reduce loads on the air handler.

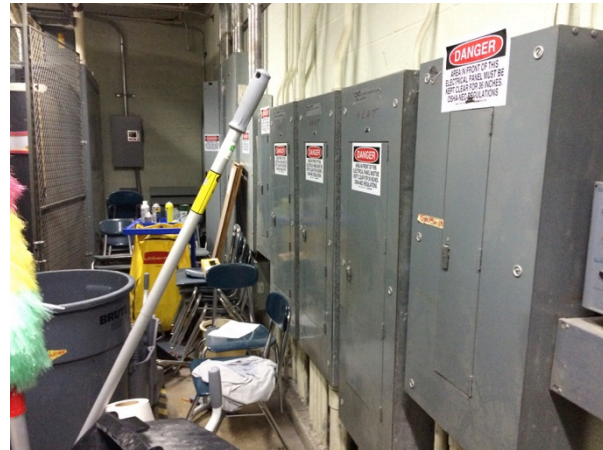
The electrical rooms are original to the construction of the building in 1972. It did not see renovations during the 2000 remodel. The panels are old but do not appear to be rusted or corroded. There are older panels in each of the electrical rooms that are not used anymore but have been left in place. There are also miscellaneous items restricting access to the panels in both electrical rooms.

The electrical room adjacent to the elevator seems to be used more for storage than it is for housing the electrical panels. This practice poses safety and fire hazards. The stored items are mostly combustible and add to the fire load of the room. If a fire were to occur, the items would accelerate its growth and spread. The second issue with all of the stored items is access to the panels. Access to the panels is critical during an emergency; there should be nothing hindering access when the electricity needs to be cut off. The final safety issue found in the electrical rooms is missing fire-stop to seal off the room from all other areas. There are gaps at the point where the wall meets the roof deck. There are also missing seals around

conduit penetrations through the walls in some places. These issues are code violations per **Appendix 5** and should be addressed as soon as possible.

Our recommendations are: remove any panels that are not in service, create appropriate storage for items required on campus, and examine all walls and barriers for appropriate fire prevention measures. After reviewing the space usage throughout the facility, there is clearly a need for additional storage capacity. A permanent or moveable storage locker would be appropriate for the school. There are many options for these types of containers. An

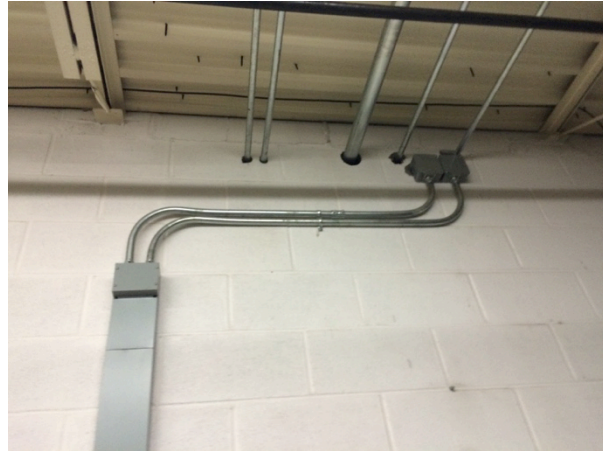
appropriately watertight system may be suitable for storing the file cabinets and other items consuming space inside the building. The fire-stop was found to be in the planned scope of work during the last renovation, but it was only partially completed in the electrical room by the elevator. There is no fire-stop in the electrical room by the boiler.

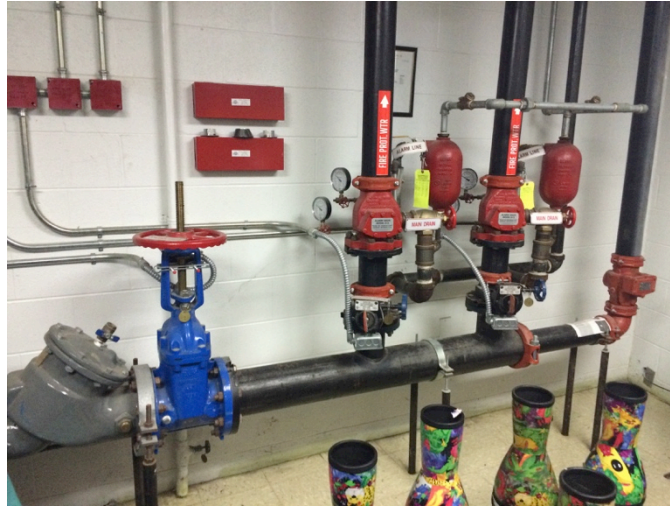
All sprinkler heads are free and clear of any obstruction; there were no signs of leaking. There is no mold build up on any of the heads. The standpipes and fire department pre-connects were free and clear of any obstructions allowing quick tie in for the fire department. The couplings did not seem to be rusted or damaged. The room where the water supply connected to the sprinkler system had some clutter in it; the room seemed to be used as

a storage area for some musical equipment. Our recommendation is to have the musical equipment and all other clutter removed. There should be nothing obstructing the path of fire department officials in an emergency situation.
