WHITMAN MIDDLE SCHOOL

Building Assessment

Executive Summary

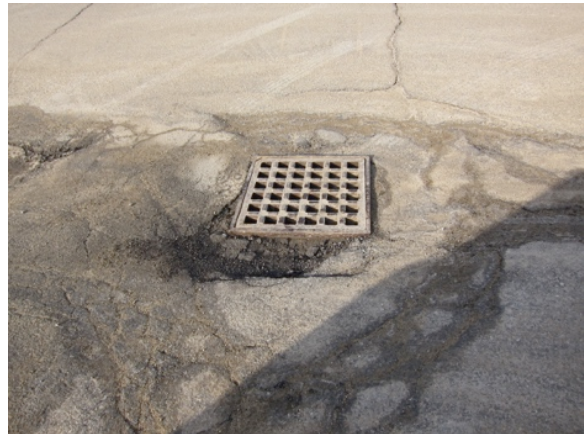
Overall, the parking lot is sufficient in size for the school. There is ample space to support daily activities at the school. There are spaces to accommodate the town's athletic events, which occur regularly during the spring, summer and fall. The pavement should be considered for resurfacing in the near future but this need does not seem critical at the time of this report.

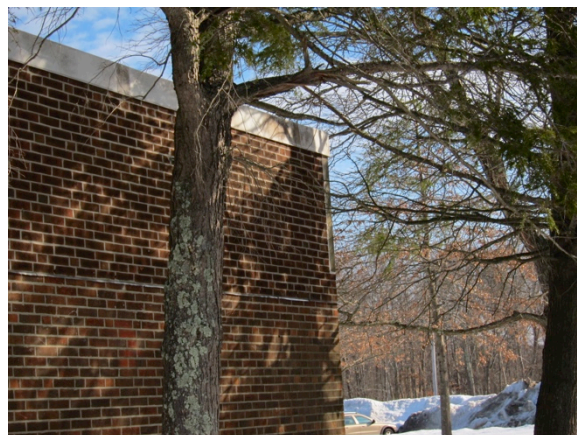
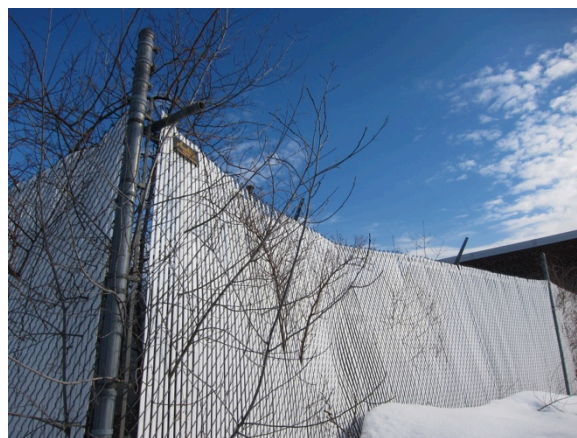
There is a security guard on duty during school hours. The security guard has an office space on site. The guard identified a few concerns to be noted. The roof has been accessible to potential vandals and small animals. There are two known access points for the roof. The first is a gas main on the west side of the building. The gas main runs from ground level up to approximately two feet below the roof. People are able to scale this main and gain access to the roof. The second is vegetation along the south side of the building. Some of the vegetation has been allowed to grow close to the building. The vegetation can be used by rodents and people to gain access to the roof. The guard also noted that security of the student's belongings while attending gym class is poor. The lockers and baskets available to the students are in poor condition and need to be updated. Finally, the guard identified the age of the camera system as a concern; there have been great improvements in the technology available for this purpose, which would enhance the ability to identify people who would vandalize the facility.

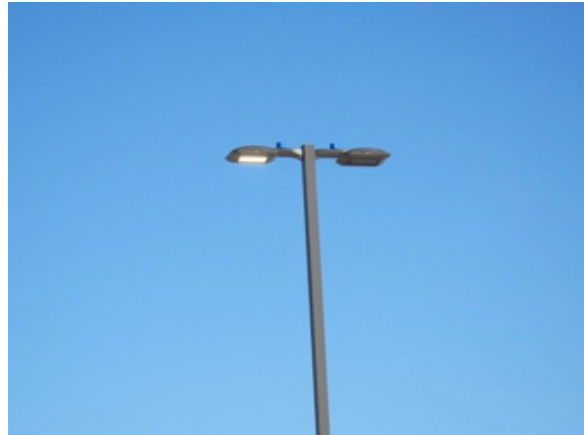
The school grounds have LED light posts covering the parking areas and metal halide lights mounted to the exterior walls of the structure. All of the lights appear to be in good working order. There are two light poles in the parking lot that require repair. The two poles appear to have been struck by plowing equipment. The wood poles do not seem to have been broken, however they are leaning and need to be placed upright again. Additionally, there is an issue with the photocell sensor for at least one of the light poles; one of the LED poles is remaining lit during daylight hours. This should be a minor repair, as all other lights seem to be responding properly to the control mechanisms.

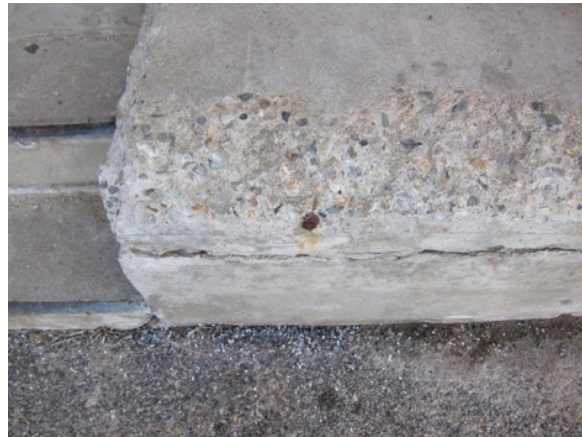
The exterior surfaces had cracks, spalling, and stains. The mortar joints around the original construction showed signs of moisture penetration and chunks of the mortar were missing. The brick surfaces were spalling in some places with frequent stains and small cracks. The expansion joint fillings were dried out and separating from the masonry. These joints are no longer weather proof. The concrete foundation surfaces were also spalling with some small cracks, and there were larger spots of missing chunks in some places. The penetration points for ventilation had larger gaps forming around the edges.

There was some damage found to the gutters and roof flashing around the newer construction near the nurse's office. A section of the gutter has broken and was hanging down from the side of the building. Along that same edge, there was a section of the flashing

that was deformed and bent upward. This damage appeared to be the result of some impact. The source was not obvious.

Repointing of the older masonry may be needed. The expansion joints should be replaced. There should be repairs made to the concrete foundation, particularly around high use places such as the loading docks behind the kitchen area. Finally, some attention should be given to the vegetation at the southeast corner of the building. Some branches are touching the building and providing easy access to the roof for rodents or vandals.

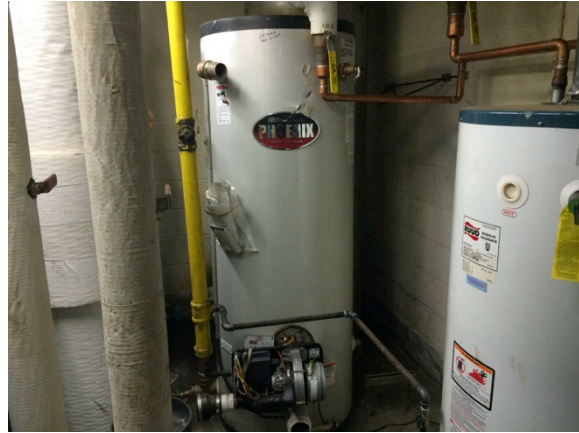
The water heater is a 75-gallon gas-burning model. The system has an 80 percent thermal efficiency. This system was manufactured in 2008 and put in place as a temporary fix when a larger system began to fail. At this time, the unit appears to be in good working order.

The amount of hot water required at any given time may be within the capacity for a tank-less water heating system. The flow rate could be achieved by placing two to three units in succession to meet the requirement. From an efficiency perspective, selecting a tank-less gas water heating system would be a good long-term solution. If not incentivized, this type of system would not have a good ROI; there is an \$800 incentive available to Massachusetts' gas utility customers, which may offset a considerable portion of the cost. If utilized, the incentive would make the upgrade well worth the investment. At this time the incentive is good for systems put into use during the 2015 calendar year. If this option should be pursued, the system selected must satisfy a $>.94$ energy factor rating on the electronic control components.

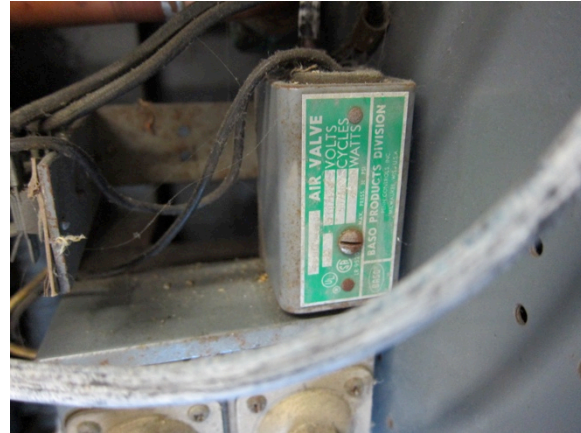
alternately and can be observed turning on every 2-3 minutes; the persistent running is indicative of leakage in the pneumatic lines.

The cabinet heaters and pneumatic controls have been a persistent source of trouble in the building. Work requests related to the system have become routine and the cost of labor associated with repairs has been increasing over recent years. Additionally, the parts needed for repairs of the pneumatic system are quickly becoming more difficult to find; these components are not generally produced today.

During the next planned renovation of the facility, both the controllers and the heating cabinets should be scheduled for replacement. The new equipment would reduce maintenance costs and provide more dependable heating throughout the facility. When this conversion takes place, consideration should be given to placement of the new circuits. The new circuits should be designed to fail in the open position allowing the heat to remain on in the event of power loss. Additionally, the controllers will require a transformer to reduce the 120-volt house system to the lower voltage digital systems.

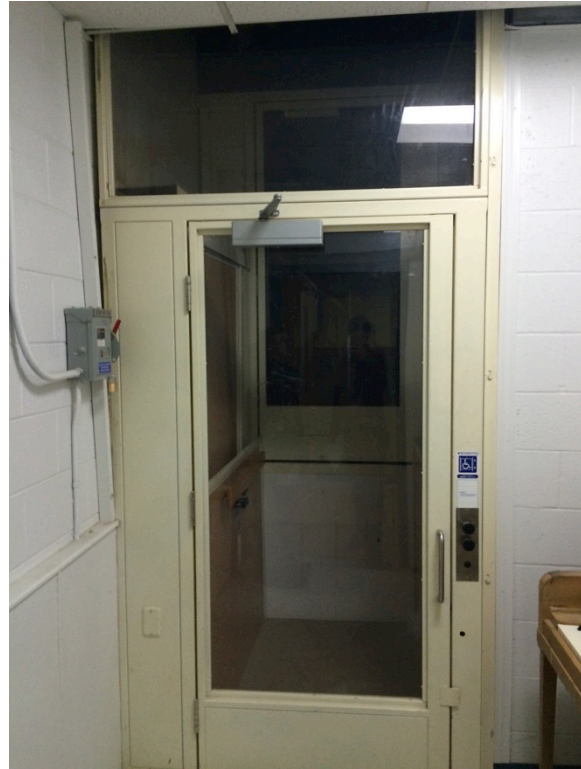
There are two lifts in the school. The first is a hydraulic elevator that provides service from the first floor to the second. It was original to the building's construction in 1972. The maintenance manuals and service records show routine preventative maintenance (PM); the elevator appears to be in excellent working condition. Upon inspection of the elevator room, it seemed to be extremely clean and well maintained. If the upkeep is continued, this system should continue to provide reliable service.

The second lift is designed for wheelchair access to the stage area. The lift was brought on line during the 2000 renovation. We were unable to find service records on this system. The system does not appear to be on the same PM program as the first elevator. Our recommendation would be to tie the two lifts together in one maintenance program. The second lift appears to operate correctly.

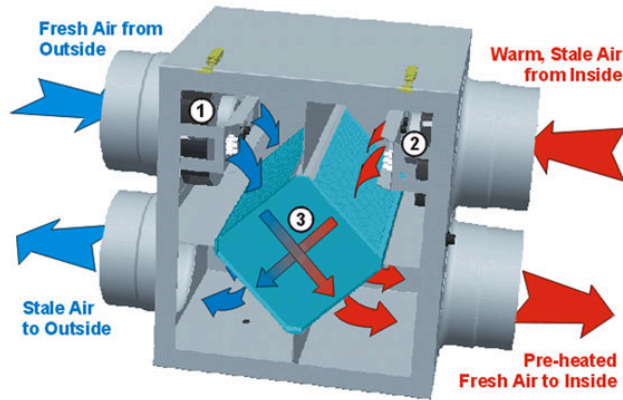
Both air handlers do suffer from small dents in their piping and ductwork. Although much of this is negligible, larger dents may cause issues with airflow in the ducts and water flow in the pipes. Any dent significant enough to impact the efficiency of the air handler should be repaired. The air handler in the gym may also be working harder to maintain occupant comfort, given the high levels of humidity in the gymnasium. Any steps taken to reduce the moisture levels in the gym would reduce loads on the air handler.

The two air handlers in the gymnasium are the only heat source. They take in fresh air from outside, heat it (if necessary) and pump the warm air into the room. The air handlers appear to be in good shape. The entire gym is controlled by one thermostat in the corner of the room. Occupant comfort is a concern in the gym, and this room could benefit greatly from having sensors and occupancy monitors installed. The pneumatic control system in the school is old and shows visible wear, and the school would benefit greatly from digital controls. Digital controls would offer better occupant comfort, more efficient use of resources, and centralized control when necessary.

One recommendation that may help resolve the moisture build up in the gym is to install a Heat Recovery Ventilator (HRV). A HRV would help expel the moisture that is accumulating in the upper level of the gym. This system would also improve the efficiency of the heating. The system recovers heat from the air that is being exhausted. The heat warms any air coming into the system before the air passes through the heating coils. The current system relies on natural air pressure to exhaust heat and moisture from the space. An active air exhaust system would improve the conditions that are contributing to the existence of mold.

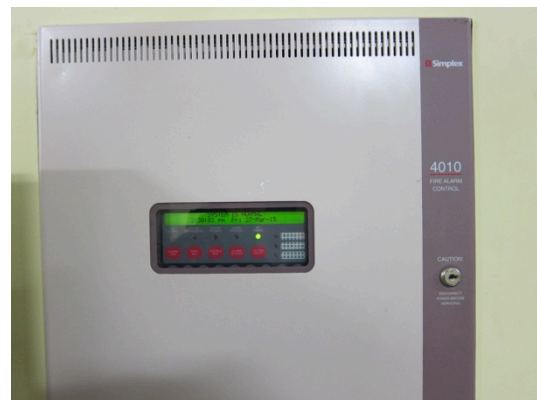
Simplex 4010 Panel

The fire alarm system seems to be excellent quality. The annunciator panel is a Simplex 4010, which works great with mid sized facilities. It has many features such as being able to detect faulty or dirty detectors, which allows for a proactive maintenance schedule to be followed. The panel is located next to the school's PA system and adjacent to the front entrance. The system is easily accessible and allows the fire department to quickly locate the problem area.
